Detailed Test Report for the Static Acceleration Testing of a cRIO Data Acquisition System

by Joseph Cavaleri Life Cycle Environmental Engineering Branch Weapons Airframe Division

OCTOBER 2014

NAVAL AIR WARFARE CENTER WEAPONS DIVISION China Lake, CA 93555-6100

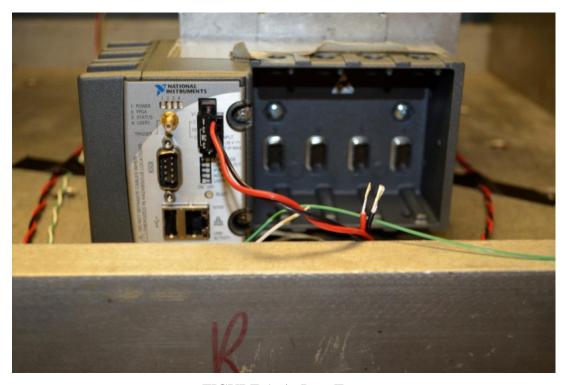
Upon inspection, the four c-modules had become dislodged and flung away from the c-RIO, smashing against the walls of the centrifuge. At least one c-module impacted the cRIO power cable and possibly damaged the internal cRIO power receptacle.

FIGURE A-4. Post-Test.

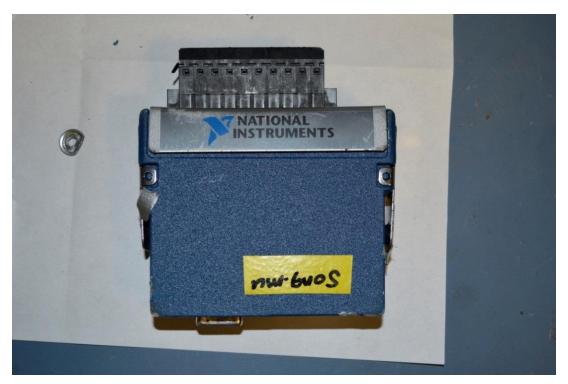
Due to the ejection of c-modules at 114 g's, the cRIO did not meet the success criteria as defined in the test plan. Restraint of the c-modules by the tool-less latching system and duct tape is insufficient to retain the c-modules in place to survive and operate in a static acceleration environment, normal to the mounting plane that is greater than 114 g's.

FIGURE A-6. Damaged c-Module, 1st Slot.

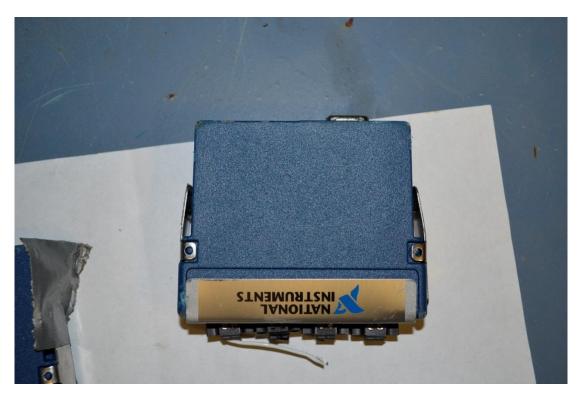
FIGURE A-7. Damaged c-Module, 2nd Slot.

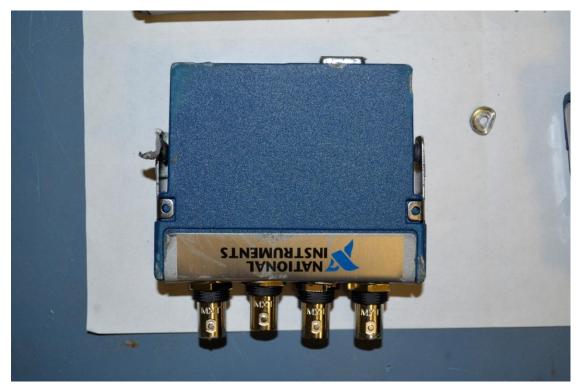
FIGURE A-8. Damaged c-Module, 3rd Slot.

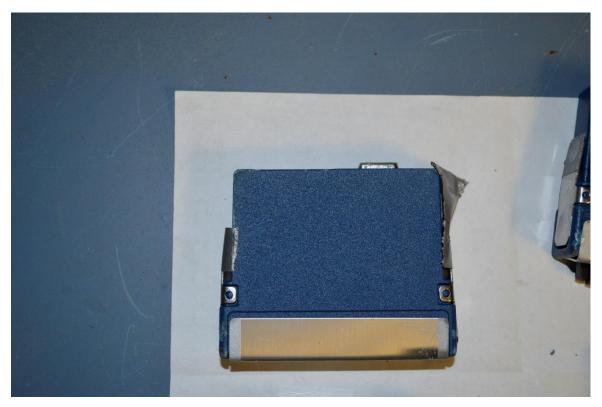
FIGURE A-9. Damaged c-Module, 4th Slot.
